White River Integrated Water Initiative

Reach Report Piceance Creek

Spring 2022

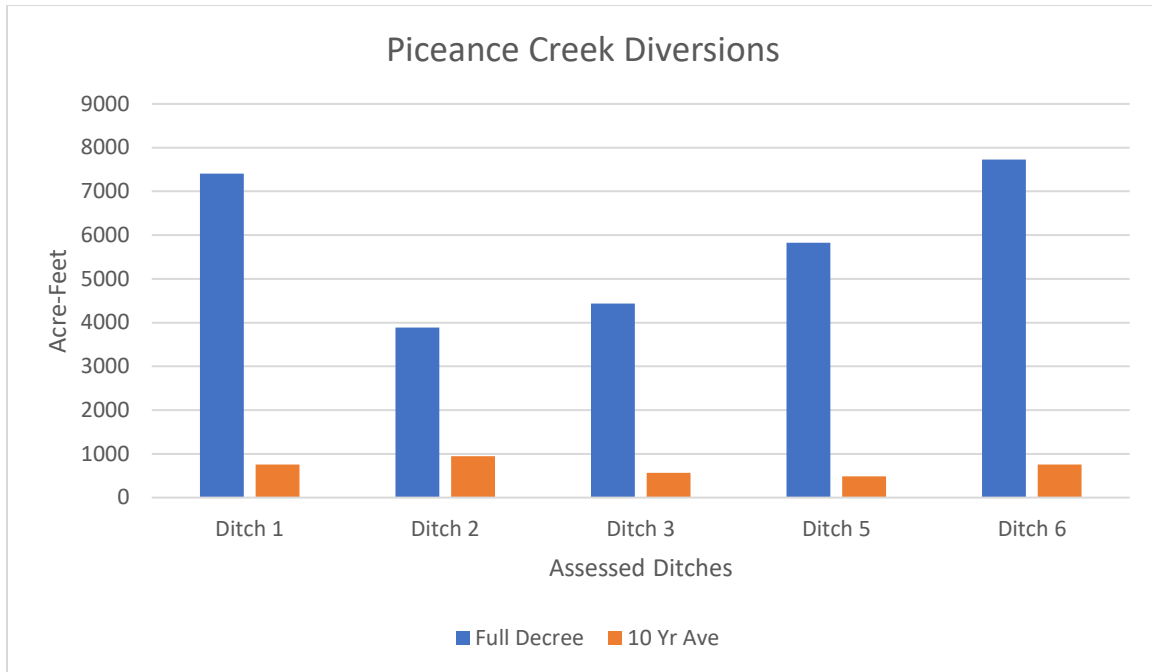
Source: CDSS Structure Report

The difference between the full decree and actual amount of water diverted is due to the lack of water available to divert.
