# White River Integrated Water Initiative

## Reach Report Lower White River

Spring 2022

## Lower Reach of the White River

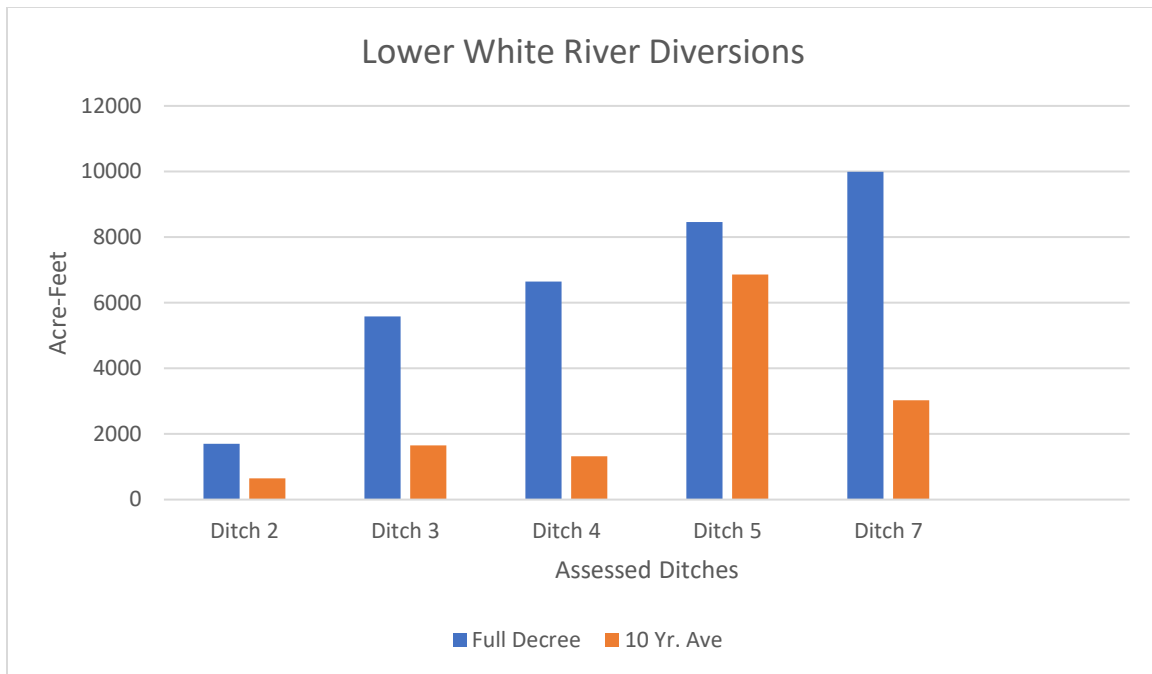
Source: CDSS Structure Report

**The difference between the full decree and actual amount of water diverted in several ditches is often due to the lack of water available to divert throughout the entire irrigation season and/or voluntary measures to maintain stream flow.**
